Manhole Inspection Summary

Manhole # S25EE_025MH

Location Address: **1806 BRUNT ST**

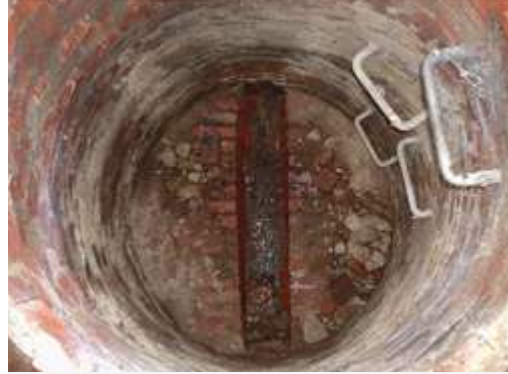
Top View

Bench and Channel debris.

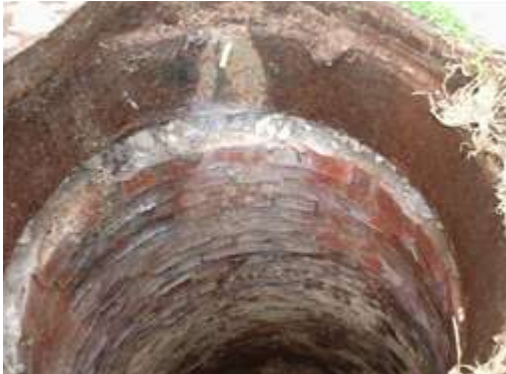
Defect

Frame leaks. Frame offset. Adjustment deterioration and infiltration. Corbel and Barrel infiltration - other side.

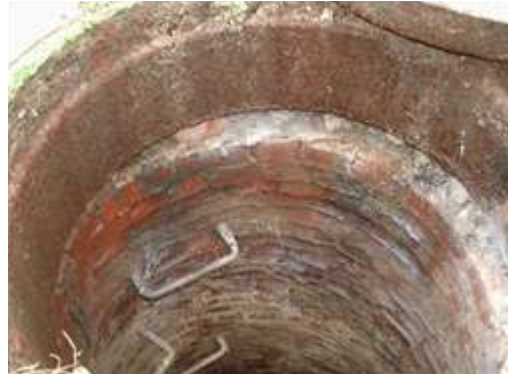
Defect

Frame leaks. Frame offset. Adjustment deterioration and infiltration. Corbel and Barrel infiltration.

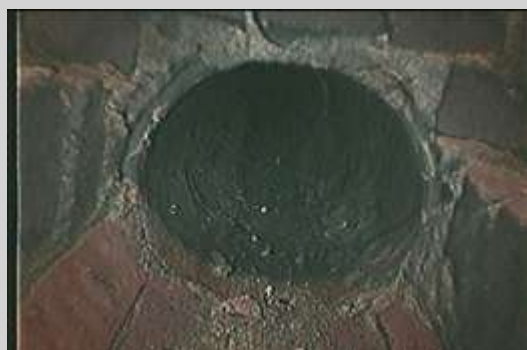
Pipe Out @ 12 O'Clock

Deposits: ☐ None ☒ **Mud** ☐ Sludge ☒ **Debris** ☒ **Grease**

Silt Depth: **0.5** (in.) Deposits Extent: **Light**

Infiltration: **Evidence** Pipe Seal Cond: **Cracked**

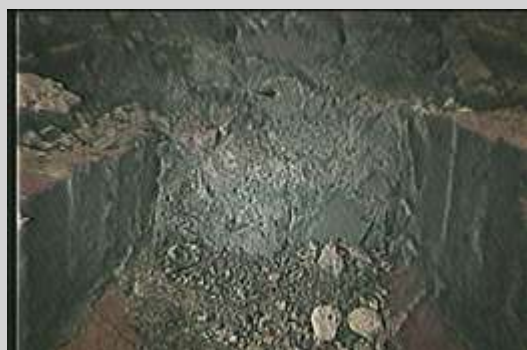
Pipe In @ 6 O'Clock

Infiltration: **Evidence** Pipe Seal Cond: **Cracked**

Connects To: **Stub connection / abandoned**
